Highly Insulated, Ventilated, Wood-Framed Attics in Cool Marine Climates

ABSTRACT

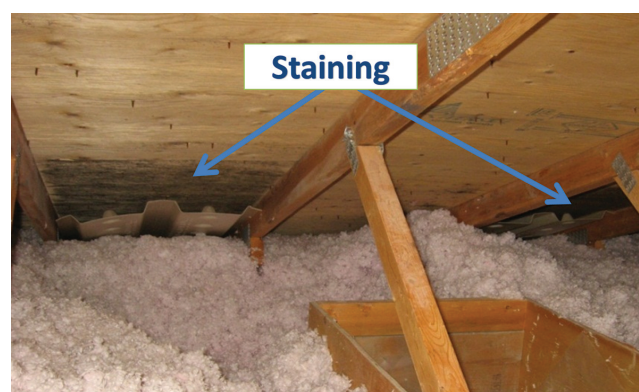
One major reason for this study is the observation of surface mold growth on wood roof sheathings of wood frame buildings that seemingly meet code requirements with respect to ceiling air tightness and attic venting area. A perfectly valid question is "Is surface mold in the attic a problem?"

Figure 1 Staining (mold) at soffit vents in a recently constructed wood-frame project.

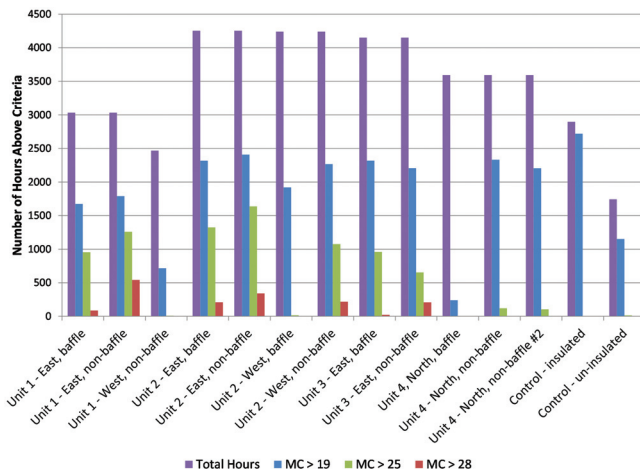
The staining and occurrence of high sheathing moisture levels are correlated, but the highest moisture for the longest duration did not necessarily coincide with the most visible staining. For example, the heaviest staining was observed at Unit 1 at the east baffle, Unit 2 at the east baffle, and Unit 3 at the west baffle, but some of the highest moisture levels were

recorded at Units 1, 2, and 3 at the east non-baffle location.⁷ Figure 12 summarizes the duration (hours) of elevated sheathing moisture levels and Table 8 summarizes observations of staining at the sensor locations at the start of the monitoring period.

Figure 12 Duration of elevated sheathing moisture levels.

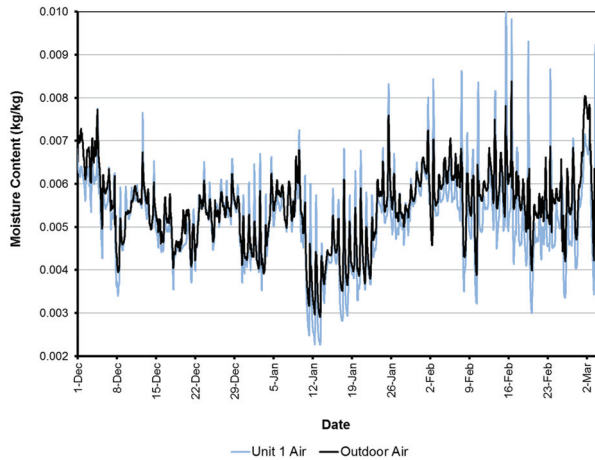
Another important observation showing that outdoor air is the principal source of wetting of the attic sheathing is the attic air has essentially the same overall moisture level as the outdoor air. Figures 13 and 14 show the attic air moisture content for Unit 1 compared to the outdoor air moisture content. The time series graph in Figure 13 shows that the attic air follows the same trend as the outdoor air. The scatter plot in Figure 14 shows that on average the attic and outdoor air are at the same moisture levels, with the attic air being slightly drier than the outdoor air at high moisture content levels.

Note that the times where the attic air moisture content levels are higher than the outdoor moisture levels coincide with decreasing moisture content levels in the sheathing and elevated sheathing temperatures (i.e., moisture is driven out of/into the wood to/from the attic air depending on the relative difference in vapour pressures).

Figure 13 Unit 1 attic and outdoor air moisture levels per time.

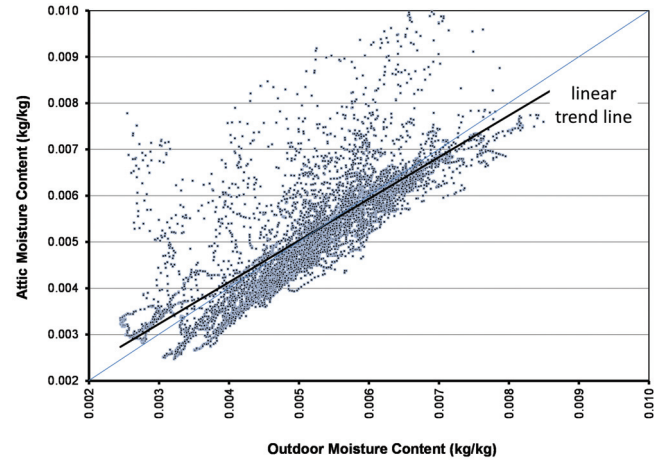
Figure 14 Unit 1 attic versus outdoor air moisture levels.

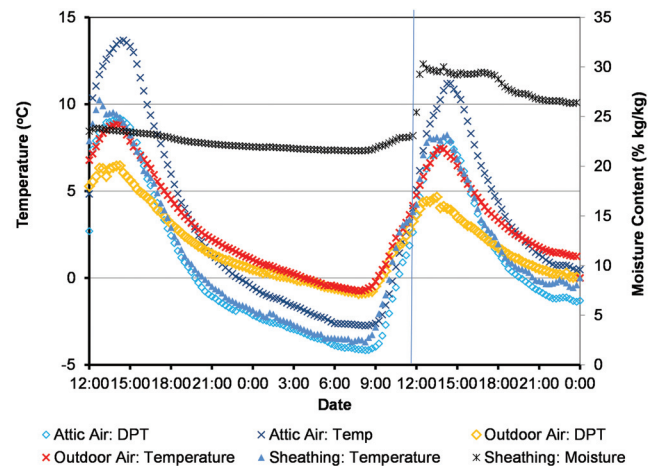
Sharp spikes in the sheathing moisture content occurred in all the units at the same time and appeared to happen when moisture was deposited by condensation or frost as a result of surfaces cooled by night-sky radiation that was subsequently exposed to warmer humid outdoor air as temperatures rose in the daytime. Figure 15 illustrates these conditions for Unit 1 on December 12, 2011. Review of the weather records for the night before this wetting event showed periods of clear skies during the night, and this was also the case for the night before the significant wetting period on January 12, 2012 and in January 2013.

Figure 15 Unit 1 sheathing moisture spike after night-sky cooling on December 12, 2012.
