A CASE STUDY FOR WATERPROOFING BELOW GRADE WALLS SHORED WITH CONTINUOUS SOIL MIX TECHNOLOGY USING A BENTONITE WATERPROOFING SYSTEM

Amanda Prot, Rodney Lock, Stephane Hoffman

25th International RCI Convention & Trade Show – Orlando, Florida

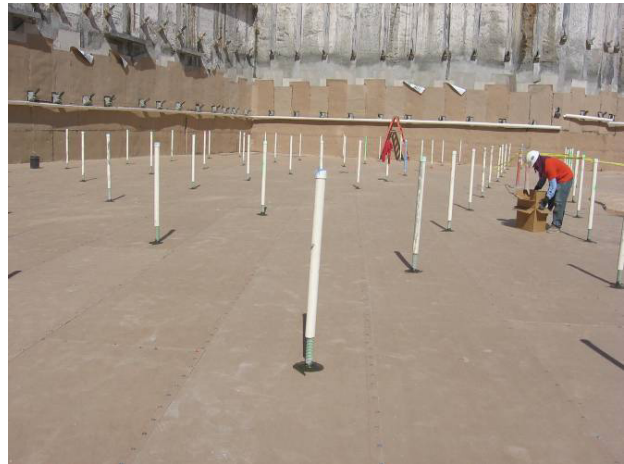
Image 1 – Bentonite waterproofing membrane installed over rat slab and sealed around tie down penetrations

The waterproofing system was required to extend under the mat slab and all sump and elevator pits and to be tied into the wall panels in order to provide a continuous water tight assembly. Refer to Image 1 for an overall view of the bentonite membrane over the “rat” slab and tie down anchor penetrations. A two layer “rat slab” was utilized with a single layer of bentonite membrane sandwiched between the slabs after drilling of the tension piles through the bottom slab was completed. The top slab was used to provide a smooth and dry surface for the installation of the waterproofing membrane with the top layer providing a protection layer for the membrane as well as a solid working

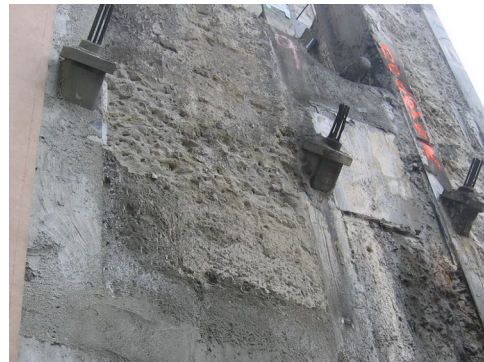
The CSM shoring walls although intended as flat and relatively smooth are often wavy and have areas of voids. Refer to Image 4 for view of voids and inconsistencies in the face of the CSM wall. It was determined that the waviness of the walls would not be an issue but that the bentonite must be installed in direct contact with the substrate and any voids larger than 2 inches would require to be smoothed. Review of a similar CSM shoring wall was reviewed and it was determined that only approximately 10% of the surface of the shoring wall would be likely to require smoothing out. This allows for the shotcrete structural concrete to be applied directly against the membrane to confine the bentonite.

Image 3 – Sample of CSM shoring wall prior to being prepared as bentonite substrate

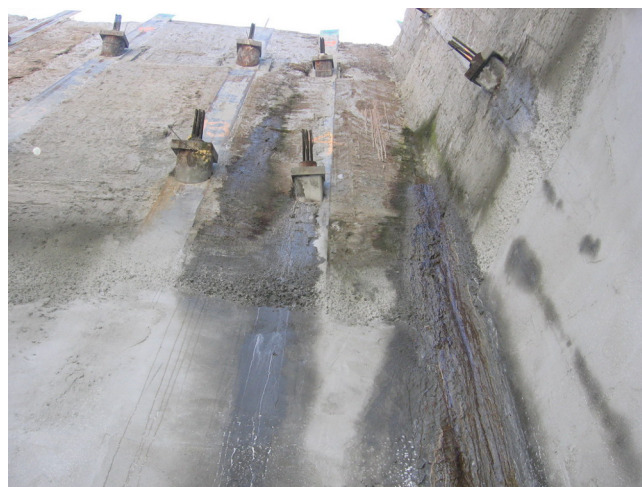
As was expected, the CSM wall did not provide a completely water tight cut off wall. Water seepage from the perimeter water table was common at joints in the CSM and especially at the tie back anchors. Refer to Image 4 for typical seepage down CSM wall. In order to maintain a clean and safe work area as well as keeping the bentonite products from premature hydration and damage this water needed to be controlled as much as possible. A temporary system of gutters was installed at the upper levels of tie backs to direct the water away from dripping down the walls and onto the slab. These gutters were still not able to capture all the water and other methods of addressing the water were needed. This included vacuuming ponding water from work areas, heat drying the concrete substrate at the perimeter walls prior to installation of the waterstop at the horizontal cold joints at floor slabs and shotcrete foundation walls.

Image 2 – Water seepage through CSM wall at tie backs

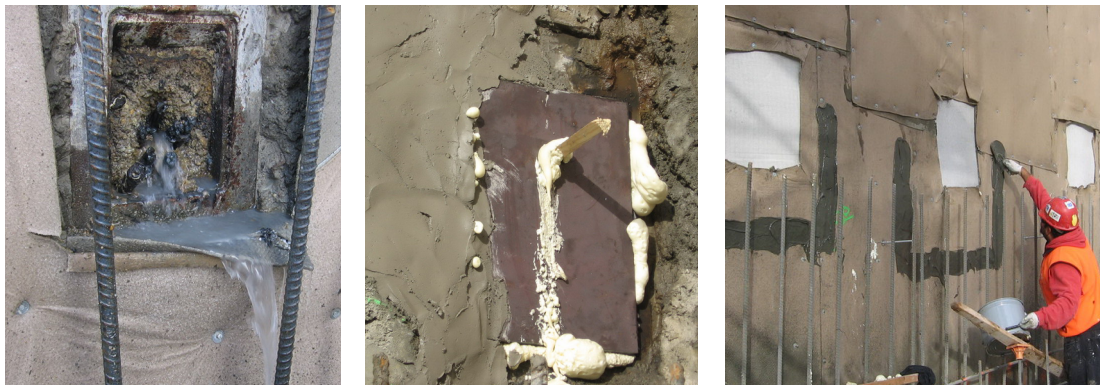
De-stressing and cutting off the tie back anchors resulting in the tie backs being inboard of the exposed side of the shoring wall. The recessed areas were to be grouted flush and smooth with the CSM shoring wall. This condition allowed the bentonite membrane to be patched directly over these grouted tie back anchors without a boot over the tie back. Due to the hydrostatic pressure at the tie backs, significant amounts of water infiltration was experienced at these tie backs once they were cut off. As a result, tie backs were cut off just prior to patching of the bentonite over the tie backs. The drainage slots through the membrane at each floor line allowed water from the tie backs that entered behind the membrane to be removed. Rapidly expanding spray foam water cut off was used at the tie backs to stop gushing water and to provide a smooth surface around the tie backs. The bentonite patches consisted of one patch of the HDPE lined bentonite membrane installed between the two field membranes and a second bentonite patch installed over the face of the field membrane with all edges sealed with a 3 inch strip of bentonite mastic and fastened at 6" on center around the perimeter. Refer to Figure 3 for detailing of the bentonite membrane at the tie backs and Image 5 for photographs of the tie back cut off process.

Image 3 – Tie Back removal, capping to prevent water seepage and bentonite patching over tie backs
