Highly Insulated, Ventilated, Wood-Framed Attics in Cool Marine Climates

ABSTRACT

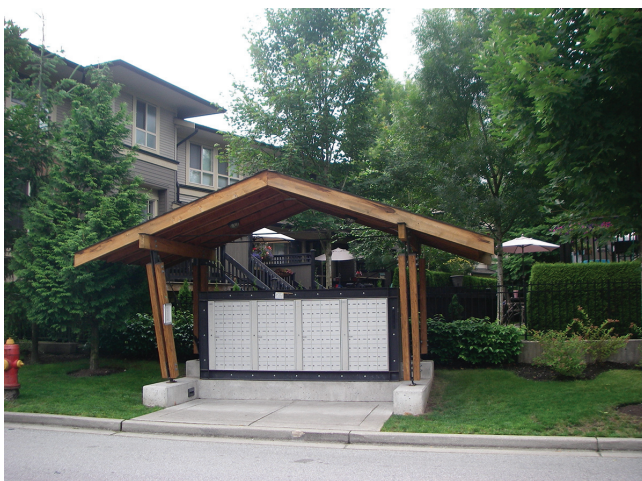
Figure 6 Test (control) roof assembly with Unit 2 in the background.

The test (control) roof assembly shown in Figure 6 was selected because this sloped roof is not subject to moisture sources from an occupied space and has similar weather exposure as the test units. The wood sheathing tested in this assembly allowed us to evaluate the conditions of the roof sheathings in an attic with abundant ventilation. The test roof assembly included monitoring of plywood samples that were installed directly below the roof underlayment and at the underside of R-5 extruded rigid insulation that was attached to the underside of the roof structure. Figure 7 shows the plywood samples for the test roof assembly. This side by side comparison allowed us to also evaluate the impact that condensation due to night-sky radiation and rain-water absorption through the asphalt singles had on the wetting of the plywood samples.

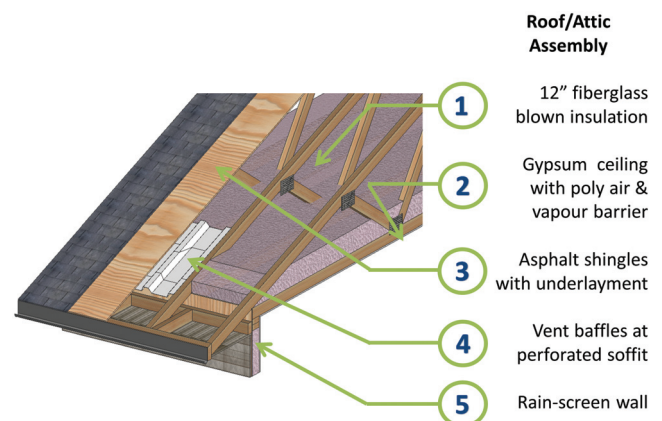
Figure 8 Attic construction and ventilation

The attic construction and ventilation (shown in Figure 8) is typical of sloped roofs for wood-framed buildings in coastal BC. As required by code, the venting area is provided at the top of the attic near the ridge line and at the bottom of the attic space at the soffits at opposite ends. The vents at the ridge are square low profile vents and baffles are installed at the soffits. Unit 4 is the end of the building and is part of the hip roof end.
