QUANTIFYING THE BENEFIT OF VENTING GLAZED SPANDRELS TO REDUCE GLASS BREAKAGE AND CONTROL MOISTURE

Julien Schwartz, Patrick Roppel, Stephane Hoffman, Neil Norris

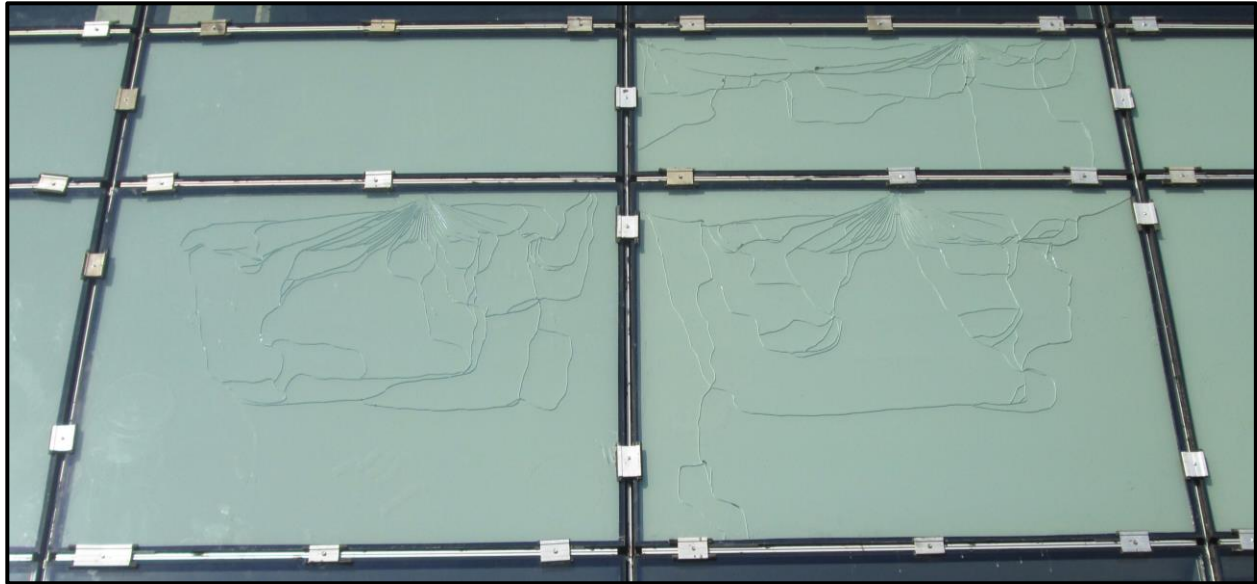
Insulated glazing units are increasingly being used in spandrel assemblies either in shadow box installations or with an opacifier on the 4th surface to provide some depth in appearance. There have been several recent instances of glass breakage in insulated glazing units in spandrel applications in the USA and Canada on the west and east coasts as well as in Russia and Germany (Arztmann 2016). Breakage has been attributed to excessive thermal stress, in both sealed and vented cavities. An example of such glazing failures in spandrel insulated glazing units is shown in Figure 1 below.

Figure 1 – Example of Glazing Failures Attributed to Thermal Stress in Spandrels Insulating Glazing Units

Anecdotal information and some research are available to support the theory that the glass is breaking in relation to thermal stress due to strength reduction in the heat-strengthened glass resulting from the application of ceramic frit to opacify the glass (Maniatis and Elstner 2016, Vockler et al. 2017) especially when compared to silicone opacifiers. This raises a question about the effectiveness of venting the spandrel cavity to control heat build-up and control moisture when using an insulated glazing unit in spandrel applications. The benefit of providing venting to control thermal stresses is not easily quantified nor is its viability as a practical solution that does not require higher strength glass for the inner lite for this type of spandrel design.

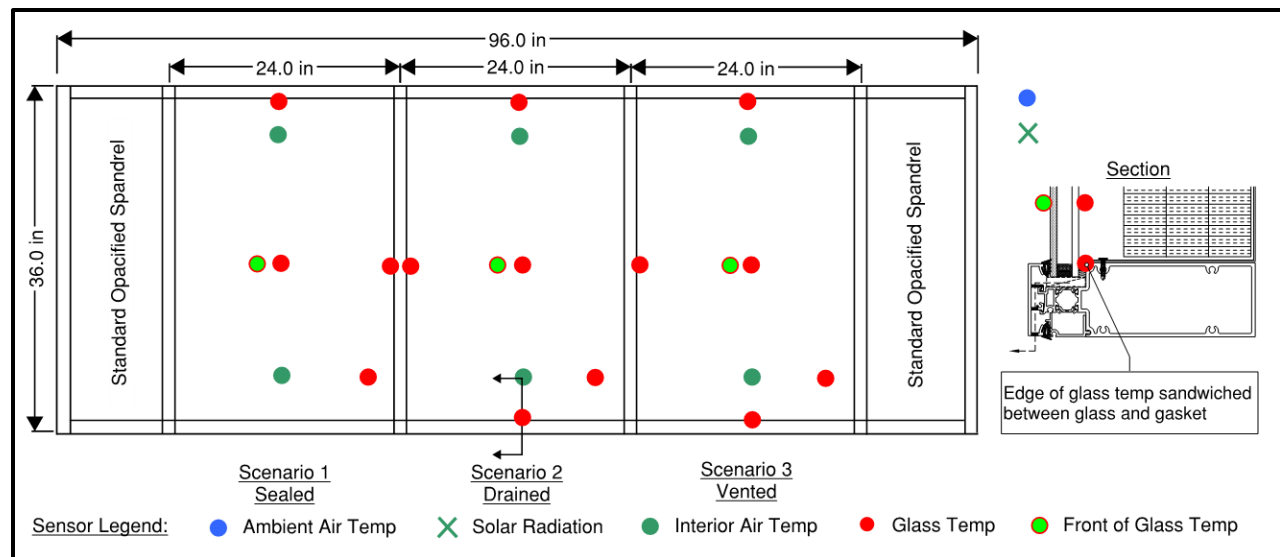
Figure 2 below shows the experimental setup with the sensors locations for the double glazed module as well as the curtain wall profile used in all spandrel sections.

Figure 2: Experimental Setup Showing Sensors Locations

1. Inner glass surface temperature at several locations inside each spandrel cavity including at the center of glass, top and bottom edges, side edges, and bottom corner edge
2. Glass surface temperature on the outside at the center of glass
3. Backpan temperature
4. Air temperature inside each spandrel cavity including at the top, bottom, and center of glass
5. Relative humidity inside each double glazed spandrel cavity at the center of glass
6. Outdoor air temperature and relative humidity
7. Outdoor solar irradiance

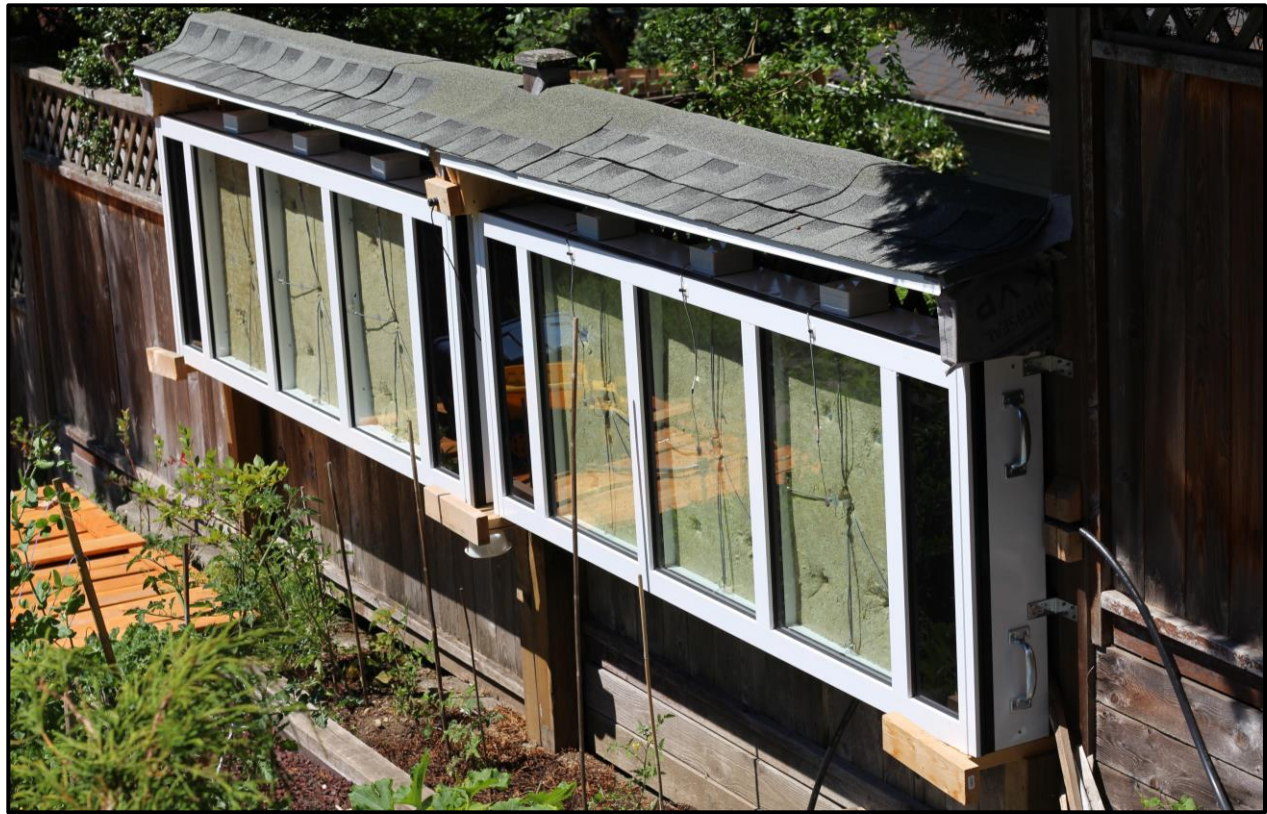
Figure 3 below shows the installed mockup with southern exposure. The 4.5 inches of mineral wool backpan insulation can be seen along with the various sensors, including the solar sensor that was installed vertically with the intent of directly capturing the magnitude of the solar fluxes that hit the spandrel sections.

Figure 3: Installed Mockup with Southern Exposure

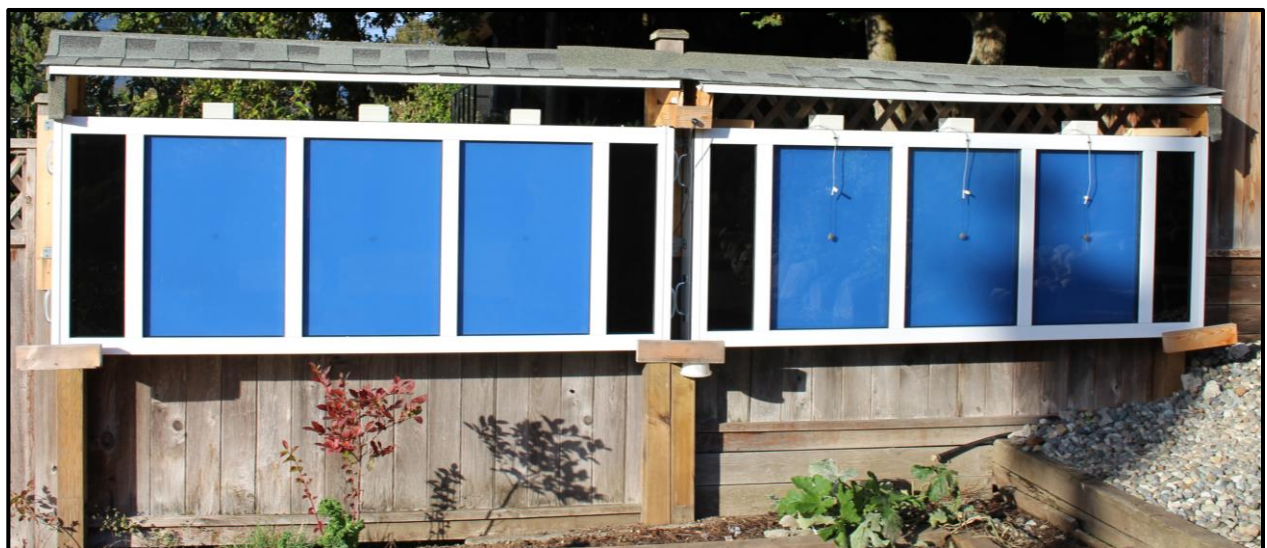
In Figure 4 below, the spandrel mockup is shown with the dark-blue Opaci-coat-300 installed on the inner pane of glass.

Figure 4: Installed Mockup with Opacified Glass Installed

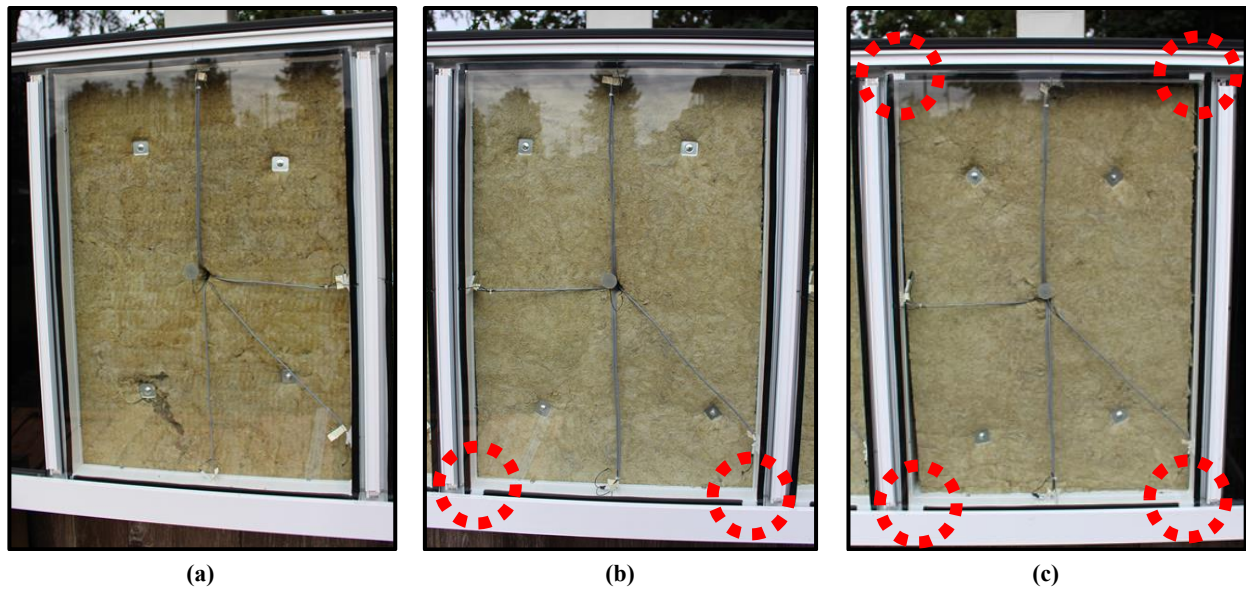
With the pressure plates removed in order to display the gaskets, the air pathways through the 1-inch gaps in the gaskets can be seen in Figure 5 below: no gaps for the sealed configuration as shown in Figure 5a, two gaps at the bottom for the drained configuration as shown in Figure 5b, and two gaps at the top and two gaps

at the bottom for the vented configuration as shown in Figure 5c.

Figure 5: Air Pathways for the Three Tested Configurations (a) Sealed, (b) Drained, and (c) Vented

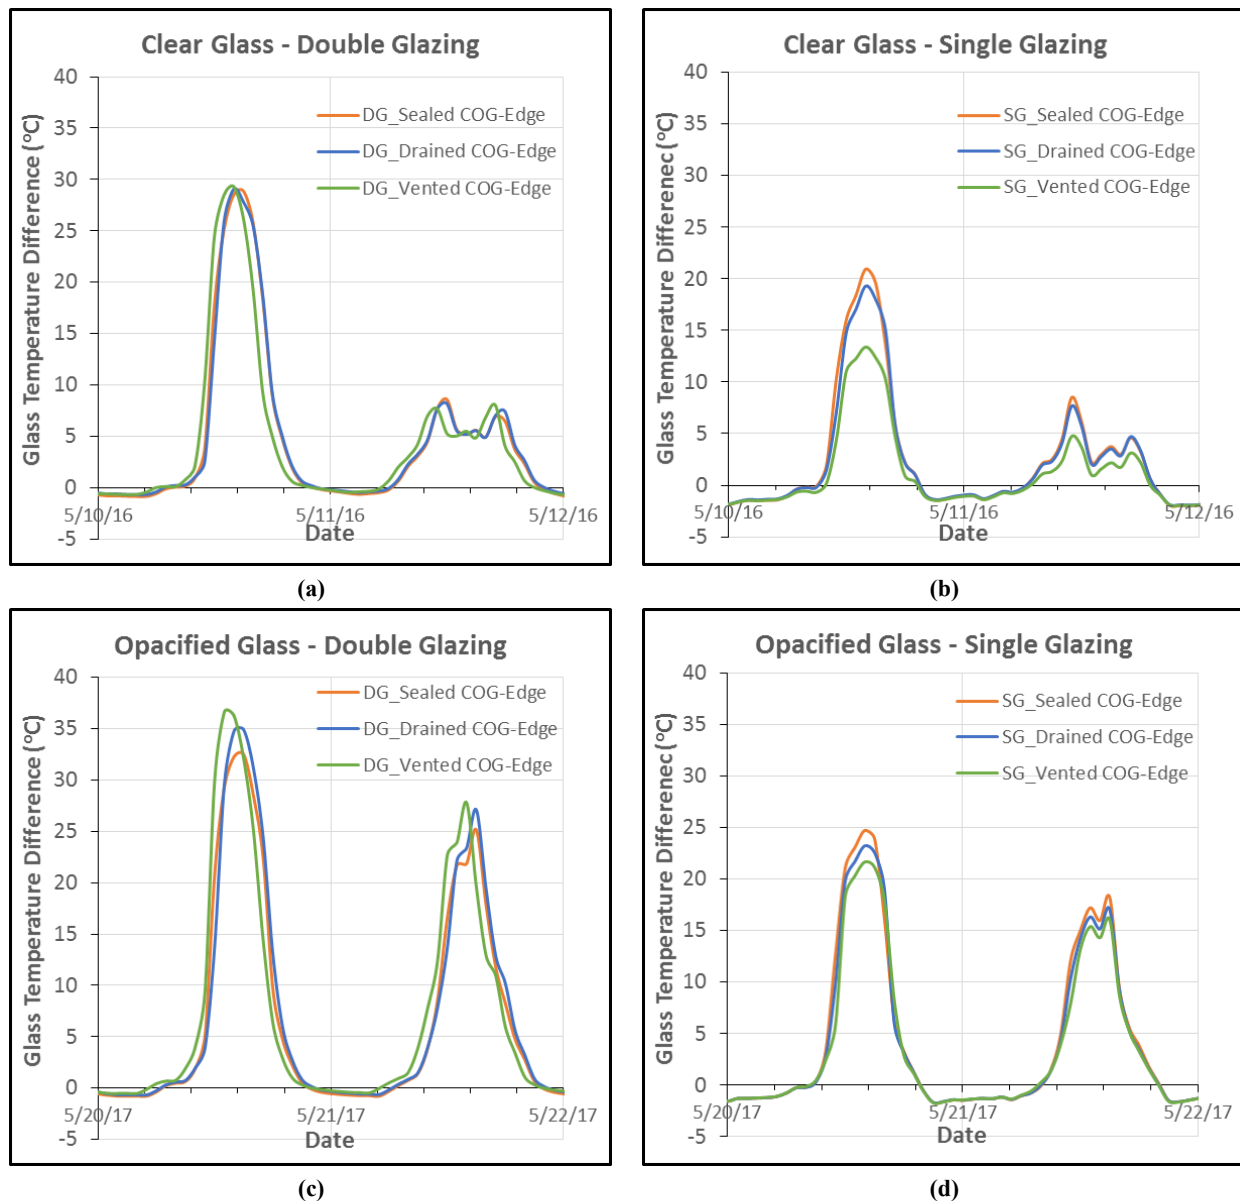
Next, glass temperature differences between the center of glass and top edge of glass were plotted for one sunny day and one day with a mix of sun and clouds for all three venting strategies for both the single- and double-glazed modules, as shown in Figure 6 below. The selected days are representative of the patterns generally observed and were chosen so that data was available for both the clear and opacified-glass scenarios, and exterior ambient conditions were comparable in terms of solar irradiance and air temperature.

Figure 6: Sample Data Plot Showing Glass Temperature Difference between the Centre of Glass and Edge of Glass for (a) Double Glazed Module with Clear Glass, (b) Single Glazed Module with Clear Glass, (c) Double Glazed Module with Opacified Glass, and (d) Single Glazed Module with Opacified Glass

Again, overall, larger glass temperature differences can be seen for the opacified-glass scenario compared to the clear-glass scenario, as expected.

For the clear-glass double-glazed scenario, contrary to the trend observed when analyzing maximum glass temperature differences, no reduction in amplitude can be seen between the vented, drained, and sealed configurations. For the opacified-glass double-glazed scenario, however, a similar trend to what was observed when analyzing maximum glass temperature differences can be seen, whereby the vented configuration sees a larger amplitude than the drained configuration, and the drained configuration sees a larger amplitude than the sealed configuration.

Now focusing on the clear-glass single-glazed scenario, a similar trend to what was observed when analyzing maximum glass temperature differences can be seen, such that there is a reduction in amplitude between the

drained and sealed configuration, and a further reduction for the vented configuration. For the opacified-glass single-glazed scenario, a similar albeit attenuated behavior can be observed, contrary to the trend observed when analyzing maximum glass temperature differences where the drained and vented configurations maximum glass temperature differences were found to be more than for the sealed configuration.

This would indicate that the typical benefits of venting single-glazed spandrel do not extend to double-glazed spandrel assemblies, which could impact the design of these insulated glazing units.

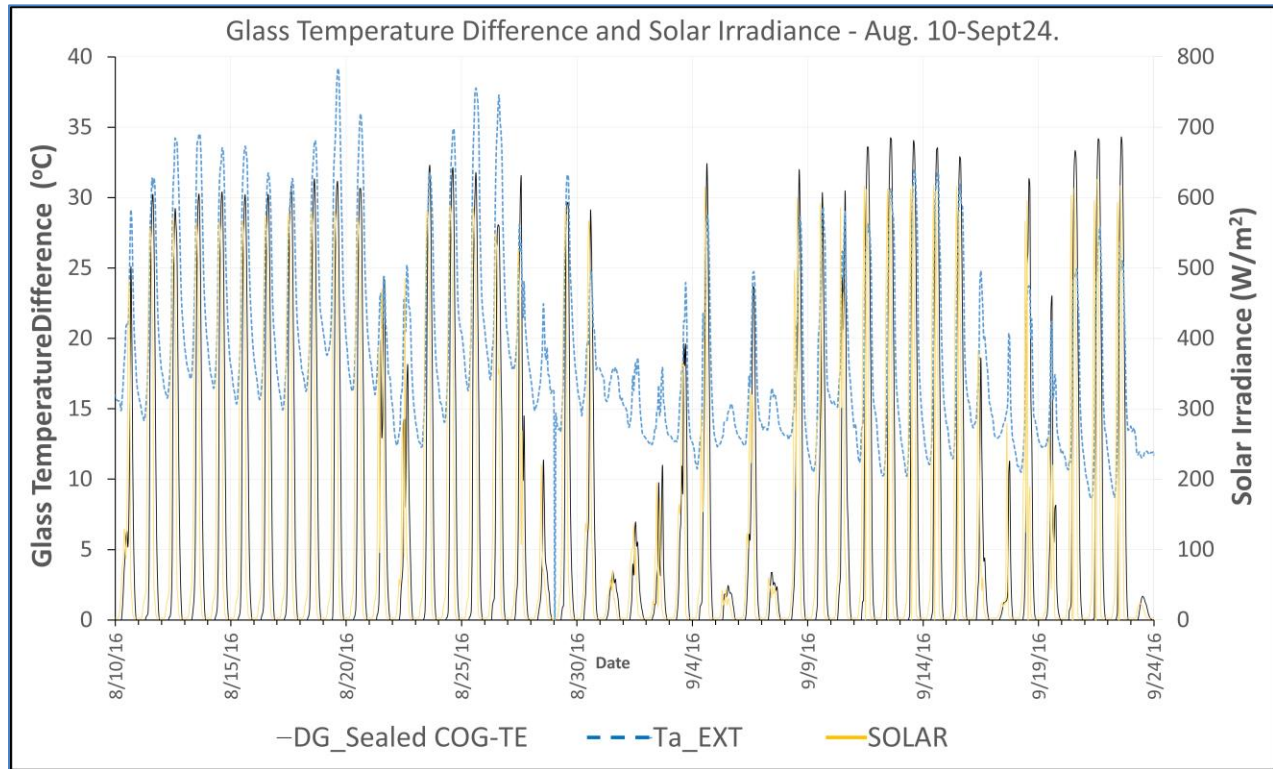
Besides comparing the impact of the three venting strategies, the recorded data also allows for the analysis of the impact of environmental factors on glass temperature difference and therefore thermal stress. Figure 7 shows recorded data of exterior ambient temperature, solar irradiance, and glass temperature difference between the center of glass and top edge of glass for the clear-glass double-glazed sealed configuration, plotted for a period range between August 10 and September 24, 2016.

Figure 7: Glass Temperature Difference, Solar Irradiance, and Outdoor Temperature from Aug. 10 to Sept. 24 2016

One observation from this graph is that there is no heat build-up overnight. Moreover, the glass temperature difference curve and peaks follow closely the solar irradiance, whether on a sunny clear day or on a cloudy or rainy day. Also, higher glass temperature difference can be seen in the month of September compared to August, with slightly higher solar irradiance (around 600 W/m² compared to around 580 W/m²) and lower exterior ambient temperature (between 25°C and 30°C compared to around 35°C). Similar behavior can be observed for the drained and vented configurations, as well as for the single-glazed module. With the more solar-absorbing assembly, this behavior is amplified. It should be noted that the highest glass temperature differences were recorded in late September for the clear-glass scenario – recall that the monitoring period for the clear-glass scenario ran from April to September – and in February and March for the opacified-glass scenario, on clear sunny days with relatively low exterior ambient temperatures. In both cases, the time of the year is when the sun is lower than in summer, so the angle of incidence relative to the spandrel sections is lower and therefore more direct solar radiation reaches the glass.

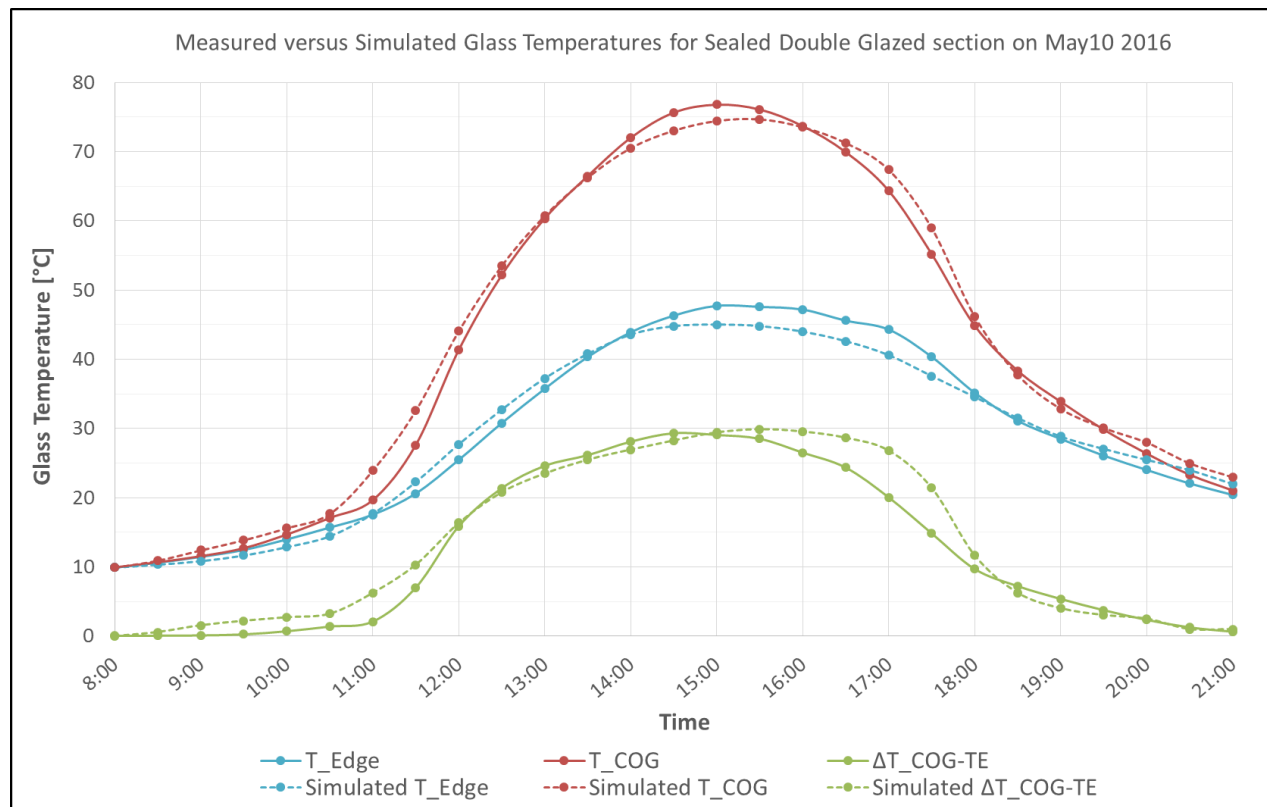
The preliminary results presented below relate to cross-validation of the field monitoring and were obtained using a 3-D model of one spandrel section with simplified geometry. As transient 3-D thermal and CFD simulations of one complete spandrel module are computationally very heavy, the intent with using a simplified geometry was to lower computation time while still capturing the physics and time-varying environmental conditions of the spandrel section. Figure 8 below shows recorded temperature data for the center of glass and top edge of glass, as well as temperature difference between the center of glass and edge of glass, for the sealed clear-glass double-glazed scenario on May 10, 2016, plotted versus simulated results obtained from the simplified model.

Figure 8: Measured versus Simulated Glass Temperatures for Sealed Clear-Glass Double-Glazed Scenario on May 10 2016

Overall, the simulated results show good agreement with the field monitoring data. Misalignment between the simulated results and the field monitoring data can be mostly attributed to geometry simplification, calculation time step and averaging, and uncertainty with local wind data as the glass convective heat transfer coefficient to the exterior is directly derived from wind speed and direction with respect to the system. For the deviation observed between 11:00am and 12:00pm, for instance, too large of a time step caused a dip in solar flux intensity not to be taken into account in the calculation due to averaging out with the subsequent higher value.
